**UNU-LRT**

*Final project 2014*

## **ASSESSING THE ECOLOGICAL STATUS OF THE HRÓARSLÆKUR CREEK, A TRIBUTARY OF THE YTRI-RANGÁ RIVER IN SOUTHERN ICELAND**

**Saidou Amadou Moussa**

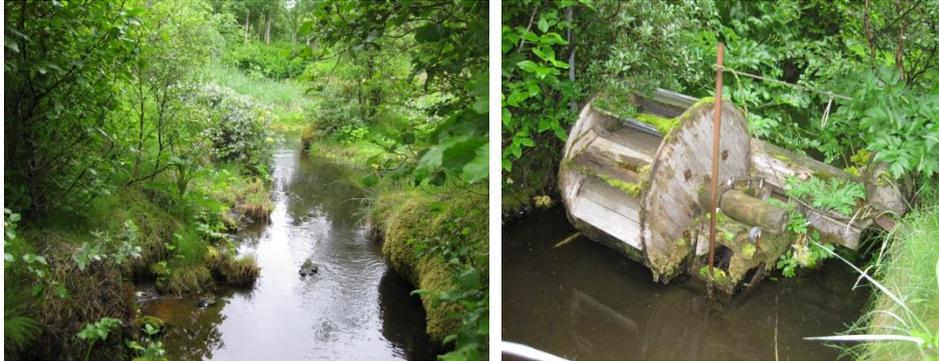
not affect the ecological status of the creek in any way. This section contains also one of the sources of the river where water comes from spring in the lava. The water depth is 10 to 20 cm and the width is about 5 m but very irregular. The banks of the creek at this point were desert in 1980 but vegetation has been restored by the summerhouse owners and the bank is now well covered with native Icelandic vegetation, for example birch trees (*Betula pubescens*). The benthic zone is sandy with stone and earth.

Figure 7. One of the sources of the creek (left) and an unused hydropower wheel (right) in section 1. Photos were taken on 26 June 2014.

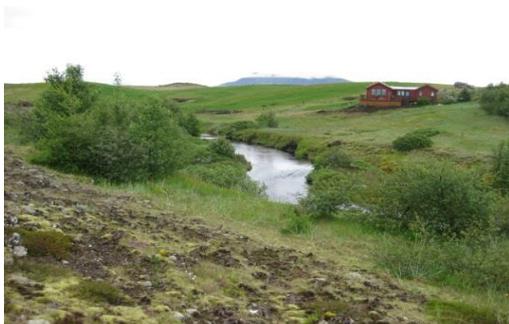
This section is characterized by grass without trees but numerous shrubs grow along the creek banks. The benthic zone is composed of sand and the flow line is meandering. The creek bank is eroded on the right side bank of the creek (not visible in the picture) when moving downstream and the vegetation cover less dense than in section 1 at the left of the creek, as shown in Figure 8. A summerhouse is located at about 100 m distance from the creek. The surroundings are mainly characterized by prairie and horse grazing areas.

Figure 8. Picture showing vegetation cover and summerhouse of section 2. Photo was taken on 26 June 2014.

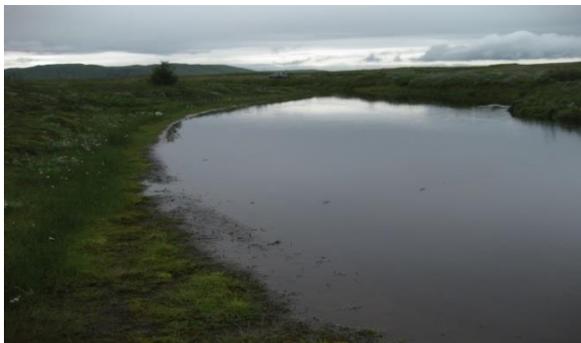
Section 3 of the creek is characterized by a sandy benthic zone covered in some areas by small rocks and gravel. The slope of the banks is steep and partially eroded. The vegetation is mostly grass with single trees. Further along the creek widens, as shown in Figure 9. The vegetation is composed of grass and shrubs.

Figure 9. Section 3 of the creek. Photo was taken on 26/06/2014.

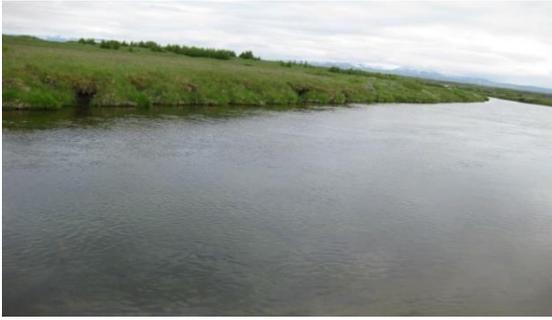
Figure 10. Vegetation cover of section 4 with grass and shrubs. Photo was taken on 26 June 2014.

Flow Line: 4  
Benthic zone: 3  
Littoral zone: 3  
Vegetation: 3  
Overall G<sub>s</sub>: 3

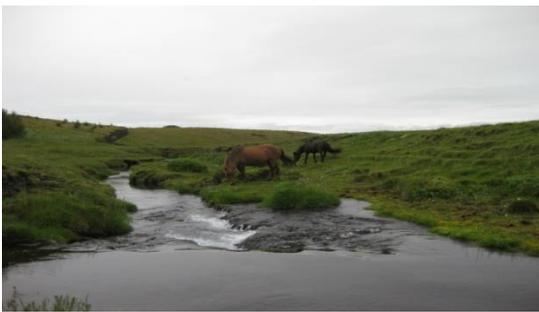
Figure 11. Photo of section 6 shows vegetation cover with single shrubs. Photo was taken on 26 June 2014.

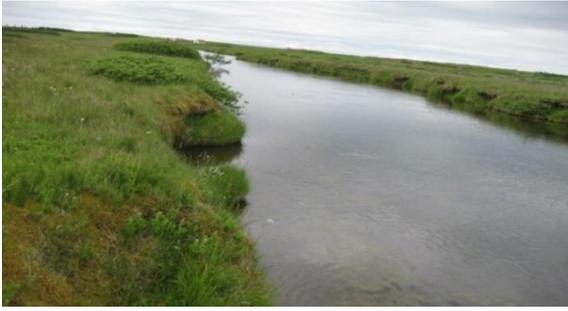
Figure 12. Photo shows littoral zone vegetation cover of section 7. Photo was taken on 26 June 2014.

Flow Line: 4  
Benthic zone: 3  
Littoral zone: 4  
Vegetation: 3  
Overall  $G_s$ : 3.5

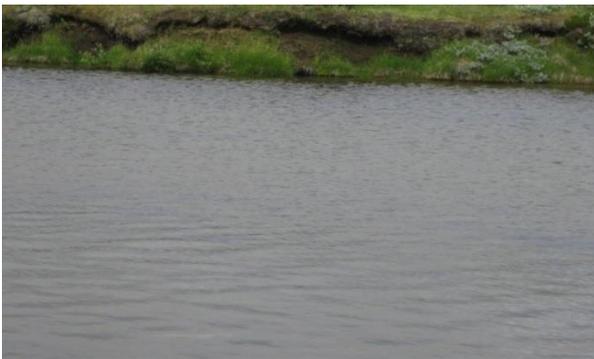
Figure 13. Photo showing eroded right side bank of section 8. Photo was taken on 28 June 2014.

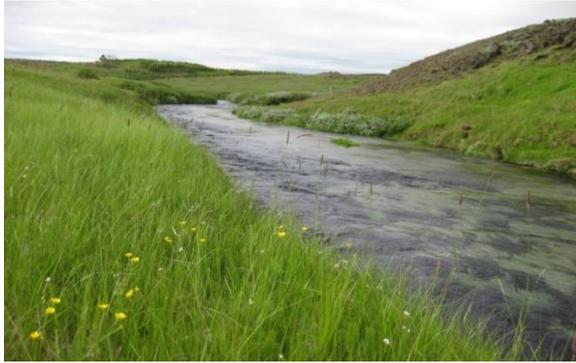
Figure 14. Photo shows the section 9 vegetation cover with sparse shrubs and eroded zone five meters away from the creek and perennial plants (*Stuckenia filiformis*) in the benthic zone. Photo was taken on 28 June 2014.

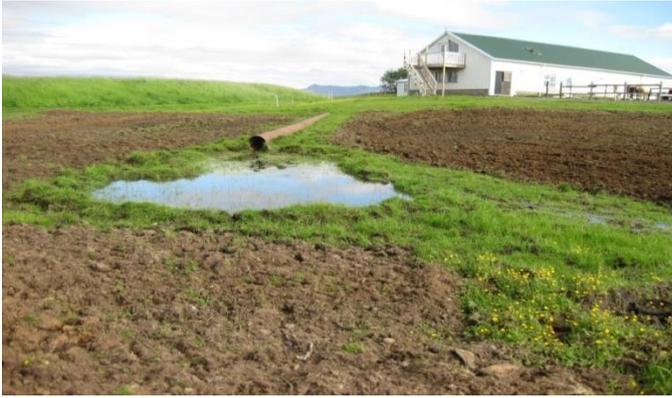
Figure 15. Hróarslækur Hotel with a pipe releasing an excess of geothermal water from the hotel in an open pit close to creek section 13. Photo was taken on 28 June 2014.

of less than 65°C. This could also have been a probable cause for the increase in water temperature in section 13 of the creek.

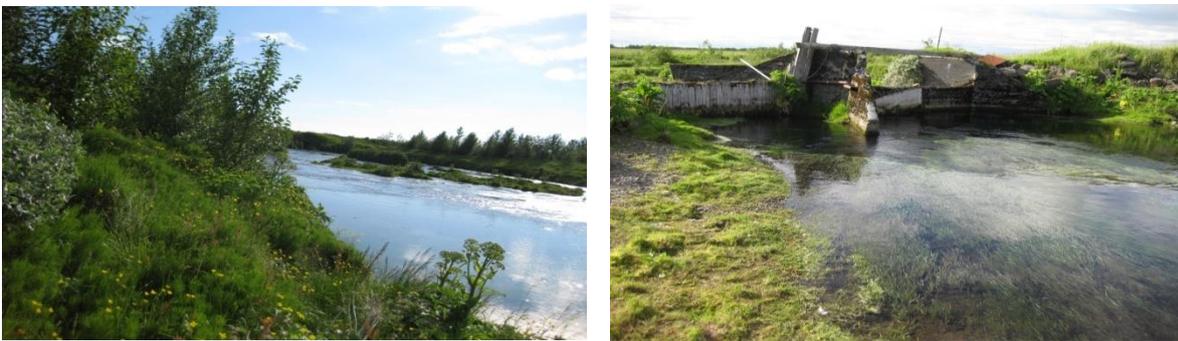
Figure 16. Vegetation cover composed of trees, shrubs and grass on restored land close to the SCSI headquarter section 14 (left) and upper dam built in 1953 used for hydropower production for Gunnarsholt (right). Photos were taken on 28 June 2014.

Flow Line: 4  
Benthic zone: 3  
Littoral zone: 4  
Vegetation: 4  
Overall  $G_s$ : 3.75

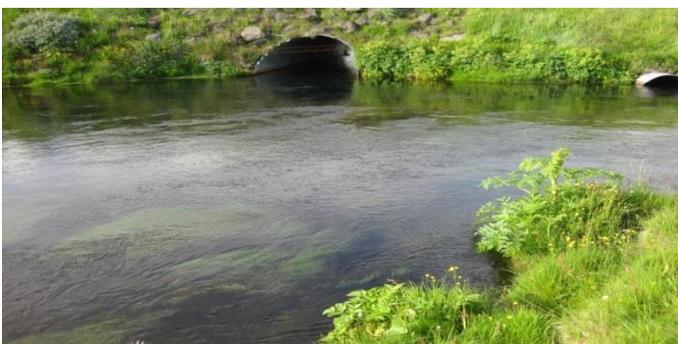
Figure 17. Photo of section 15 shows a channelized section of the creek due to the construction of the culvert. Photo was taken on 28 June 2014.

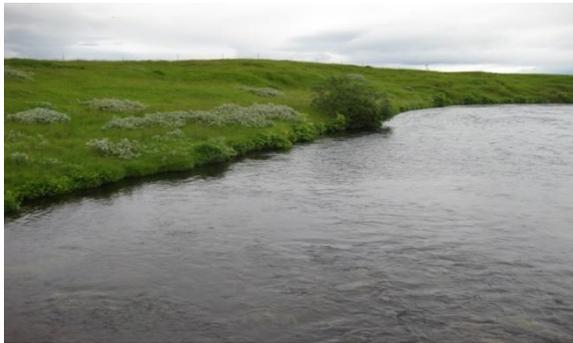
Figure 18. Photo shows isolated shrubs in section 22. Photo was taken on 5 June 2014. Classification of section 22 (refer to Table 6 for the classification of sections 20, 21 23 and 25):

Flow Line: 4  
Benthic zone: 2  
Littoral zone: 3  
Vegetation: 2  
Overall G<sub>s</sub>: 2.75

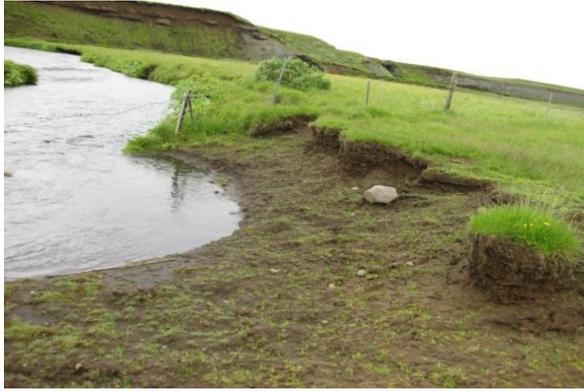
Figure 19. Photo shows eroded littoral zone of section 24. Photo was taken on 7 June 2014. During field data collection I found horses grazing around this section. Fences can be seen protecting the next section of the creek in the photo. The littoral zone is well vegetated.

Flow Line: 4  
Benthic zone: 3  
Littoral zone: 1  
Vegetation: 2  
Overall G<sub>s</sub>: 2.5

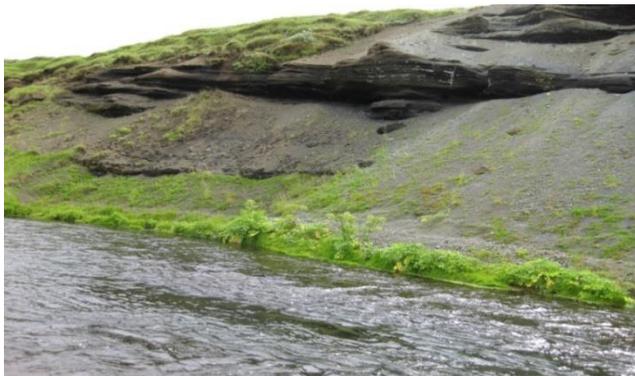
Figure 20. Photo shows the steep eroded littoral zone of section 26. Photo was taken on 7 June 2014.

Flow Line: 4  
Benthic zone: 3  
Littoral zone: 2  
Vegetation: 2  
Overall G<sub>s</sub>: 2.5

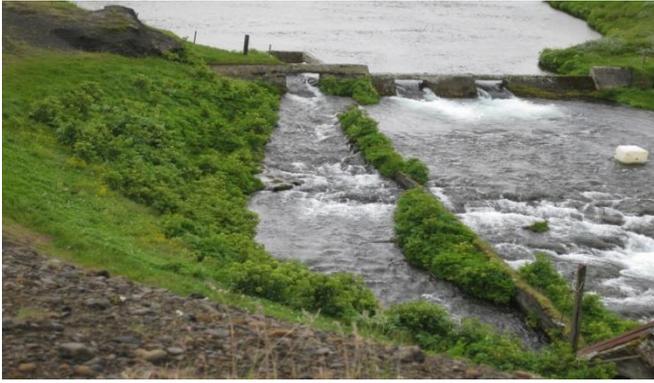
Figure 21. Photo shows the lower dam built in 1947, from unused hydropower station section 26. Photo was taken on 7 June 2014.

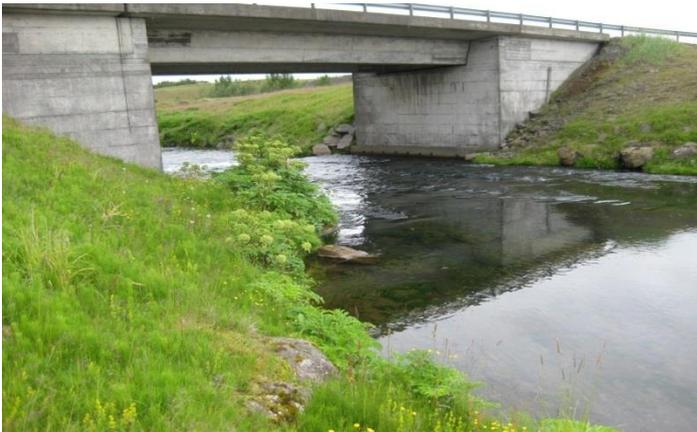
Figure 22. Photo shows channelized river section 27 under a bridge on Route 1. Photo was taken on 9 June 2014.

Flow Line: 1  
Benthic zone: 2  
Littoral zone: 1  
Vegetation: 1  
Overall G<sub>s</sub>: 1.25

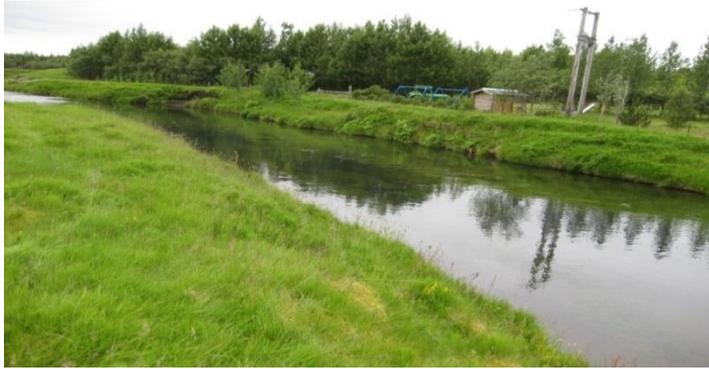
Figure 23. Photo shows right side vegetation composition of section 28. It is composed of trees, grass and single shrubs with recreational area. Photo was taken on 9 June 2014. The left side is composed of grass only.

Flow Line: 4  
Benthic zone: 2  
Littoral zone: 3  
Vegetation: 3  
Overall G<sub>s</sub>: 3

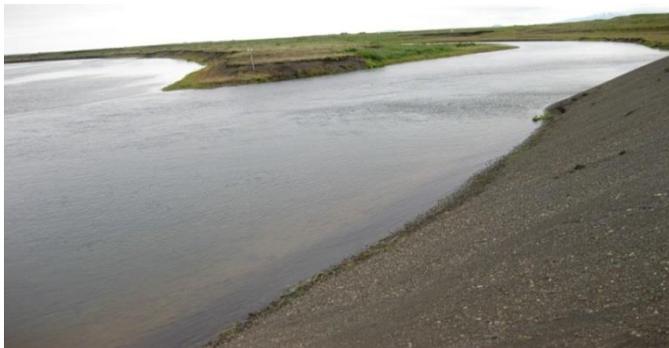
The confluence of Hróarslækur Creek with the Ytri Rangá River at section 31 is eroded. The vegetation cover is mainly grass. The benthic zone is sandy with a little gravel. The littoral zone is eroded and the flow line is meandering, as shown in Figure 24 below.

Figure 24. Photo section 31 shows the junction of the creek with the Ytri Rangá River. Photo was taken on 9 June 2014.
