**UNU-LRT**

*Final project 2014*

## **ASSESSING THE ECOLOGICAL STATUS OF THE HRÓARSLÆKUR CREEK, A TRIBUTARY OF THE YTRI-RANGÁ RIVER IN SOUTHERN ICELAND**

**Saidou Amadou Moussa**

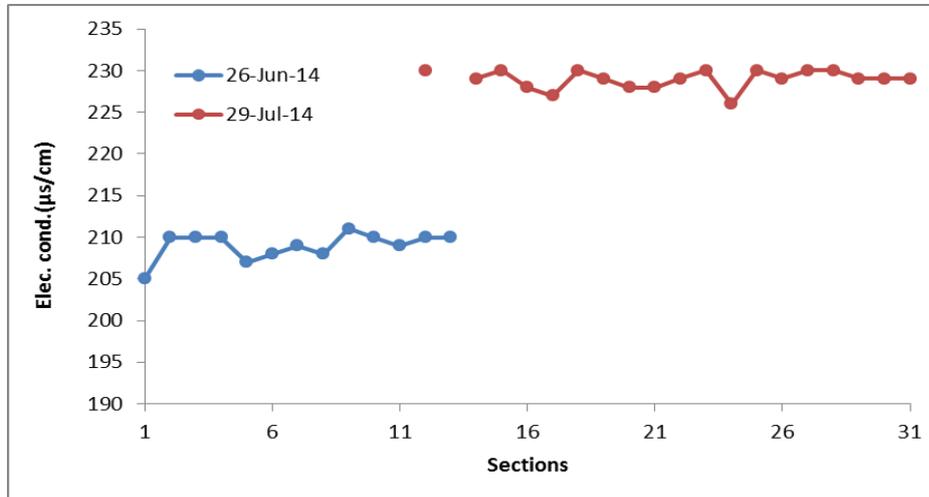
**Error! Reference source not found.** and Figure 26 show the trend of both electrical conductivity and temperature. The variation of electrical conductivity from section 1 to section 13 was between 208 $\mu$ S/cm and 210 $\mu$ S/cm. Nevertheless, it can be seen that the EC increased from section 14 to section 29 and reached 229 $\mu$ S/cm and continued to rotate around 229 $\mu$ S/cm and 230 $\mu$ S/cm (Figure 25).

Figure 25. Electrical conductivity variation along the Hróarslækur Creek. The label in the figure indicates the date when measurements were performed.

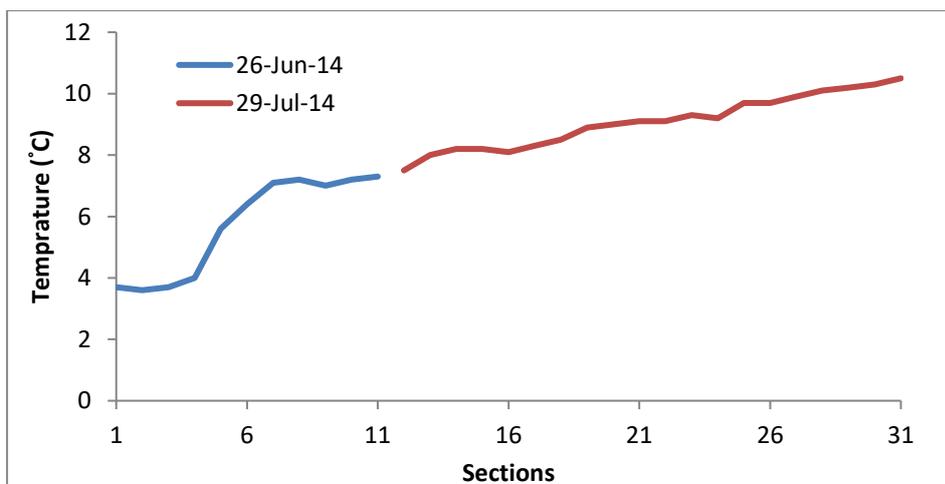
Figure 26. The figure shows the evolution of the water temperature along Hróarslækur Creek from upstream to downstream. The label in the figure indicates the date when measurements were performed.

The trend in temperature showed an increase in water temperature along the creek sections. The first readings of the temperature showed a slight difference in temperature from sections 1 to 6, as shown in Figure 26. These results are in line with the results obtained by Jonsson and Johannsson (2013). As the water coming from the source of the lava field is always very cold, the temperature increase along the creek is probably due to the warming from the ambient temperature.

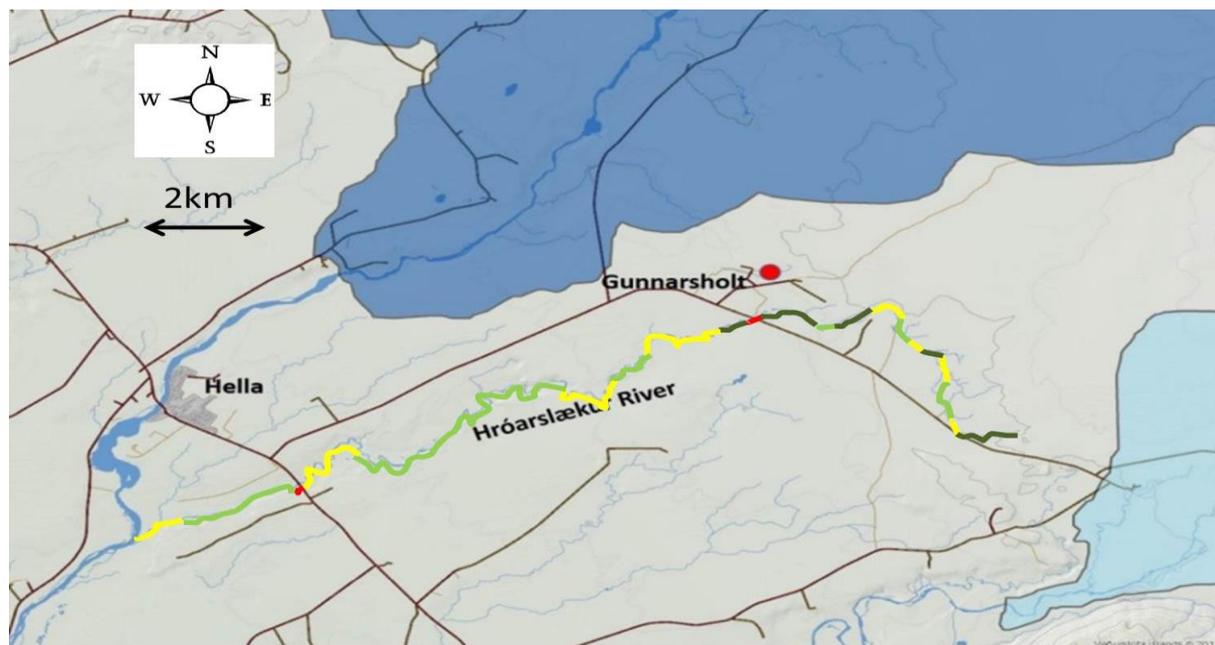
Figure 27 shows the sections of the creek based on the ecomorphological status. The green, blue, yellow and red colours signify very good, good, fair and bad condition, respectively, according to the parameters defined in Table 6.

Figure 27. Classification of Hróarslækur Creek sections. The dark green colour indicates sections of the creek that are in “very good condition”. The light green colour indicates the sections of the creek that are in “good condition”. The yellow and red colours indicate the sections where the creek is respectively in “fair condition” and “bad condition”.

- Class no. 3 is designated by a “light green colour”. In this section, the vegetation is composed of either grass or shrubs without trees or trees and grass without shrubs less in number. The benthic zone is either muddy or mud and mosses. The littoral zone is steep with less vegetation on one side and well vegetated on the other side. More than 50% of the creek sections fall in this class, as shown on the map of Figure 27 above.
